# Pheasant Branch wetland degraded by urban runoff

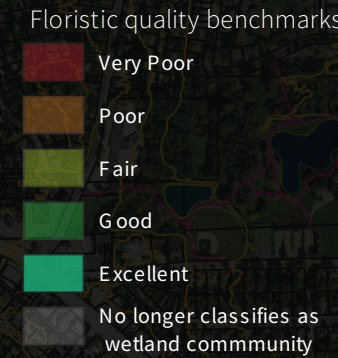
After re-routing of the Pheasant Branch Creek in mid-1960's, aimed at attenuating sediment runoff into Lake Mendota, floristic quality of the wetland is low.

When compared to benchmarks for wetland plant communities, many areas within Pheasant Branch Conservancy rank fair or poor.

Sand and sediment deposition is feet above historical wetland soils

Urbanization means increased flow and erosion in the Pheasant Branch Creek channel. Highly erodable sandy soils exacerbate bank erosion and movement of sediment downstream.

Despite significant groundwater recharge, degradation of wetland areas due to excess sedimentation is evidenced by low floristic quality throughout much of the wetland

Historically sedge meadow, this area is now a low-diversity upland forest dominated by invasive species.
